TECHNICAL INSPECTION REPORT

(6) OPERATION CROSSROADS,
U.S.S. NIAGARA (APA 87).

(8)
TEST ABLE [U].

BUREAU OF SHIPS GROUP
TECHNICAL INSPECTION REPORT

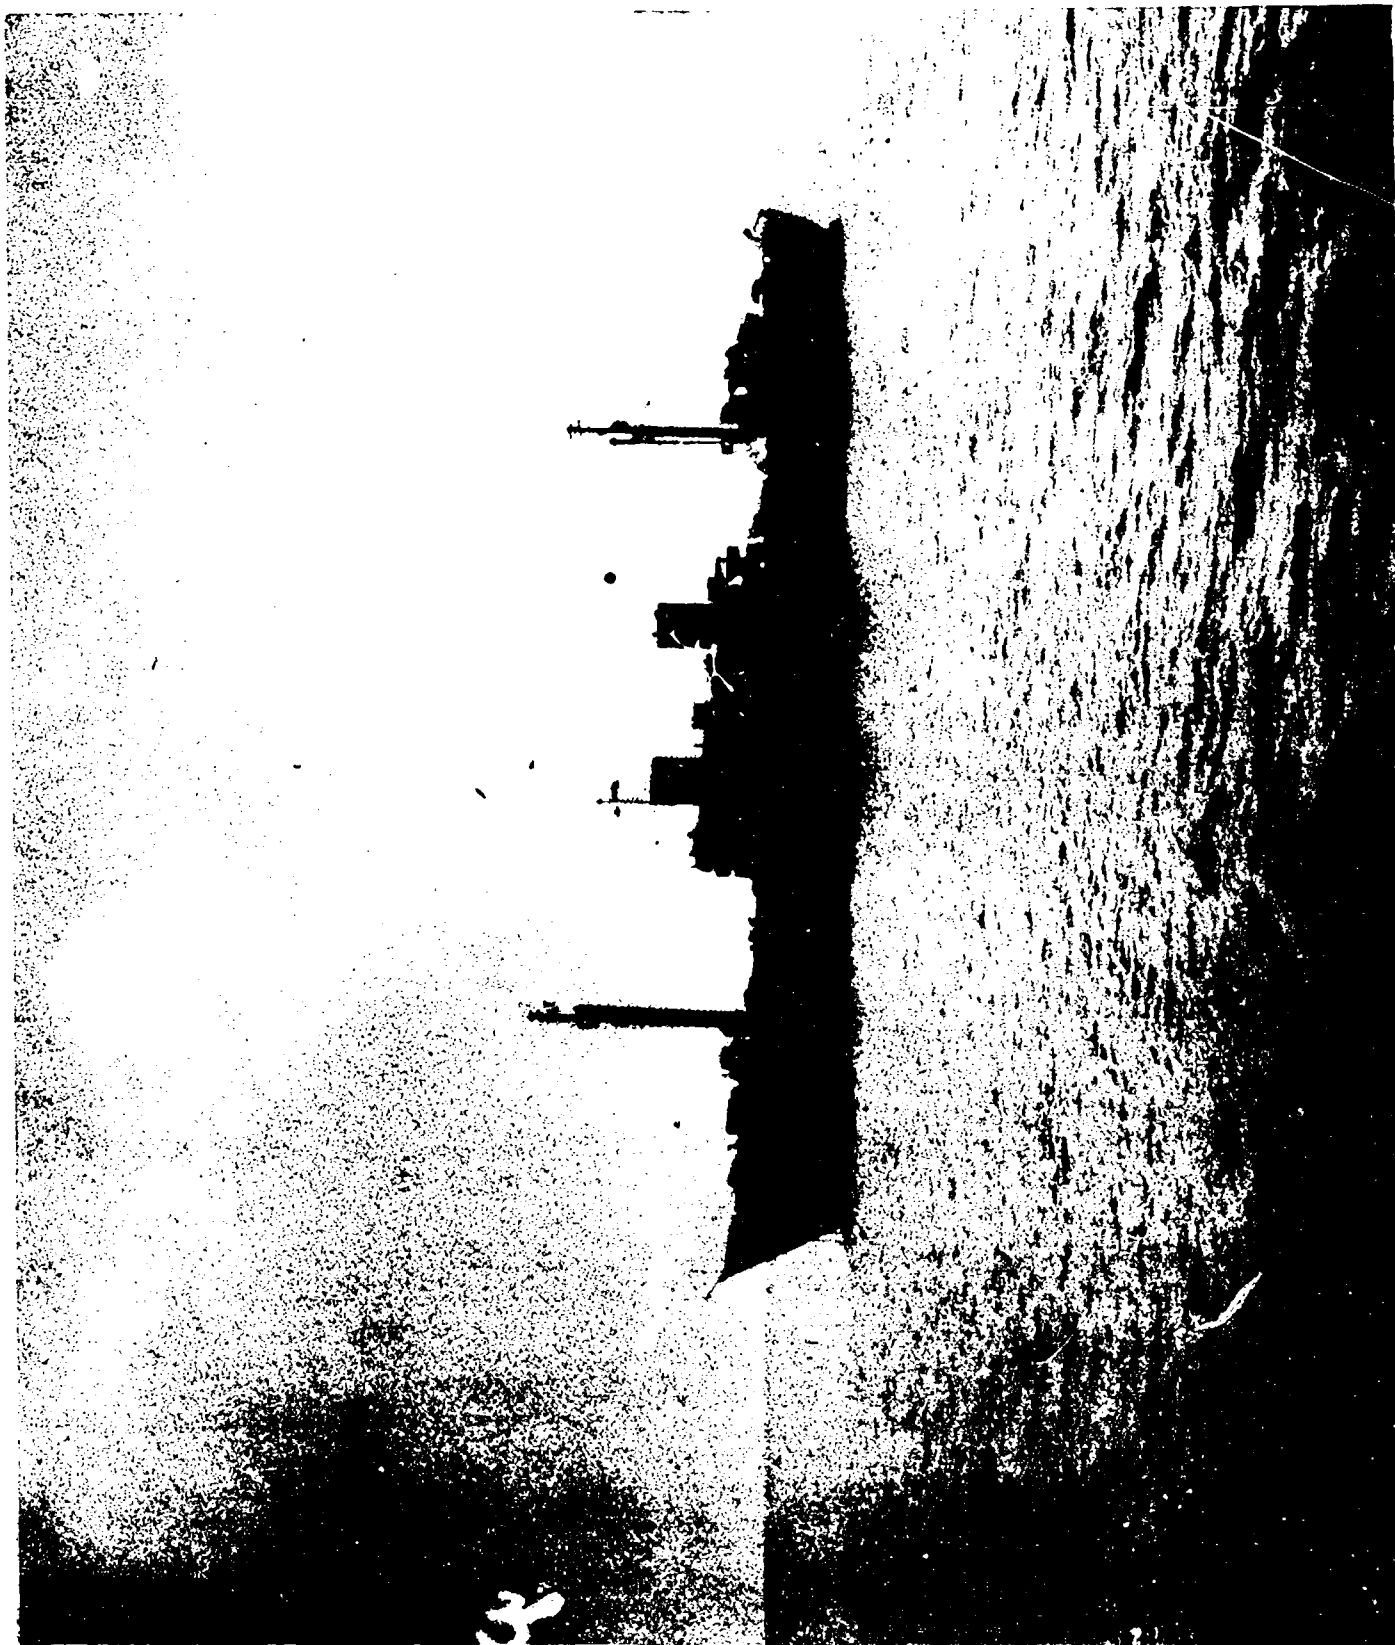
AA-CR-60-964-3. View from off port beam after Test A. Note smoke from fire at frame 113, port main deck weather passageway.
